**Flood Control Project Maintenance  
Levee Inspections**  
**LMA District Cover Sheet**  
**Spring 2018 Levee Inspection Results**

**Reclamation District No. 2085 Kasson**

**Spring 2018 Levee Inspection Results**

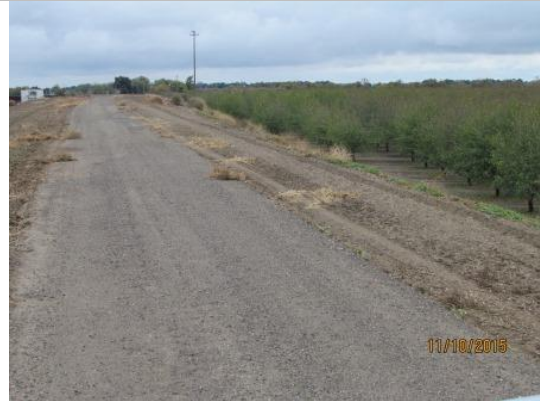
Photo 1 of 1 : SP\_2018\_RD2085\_113\_19\_20180305\_00016.jpg

View of the disking on the levee crown shoulder.

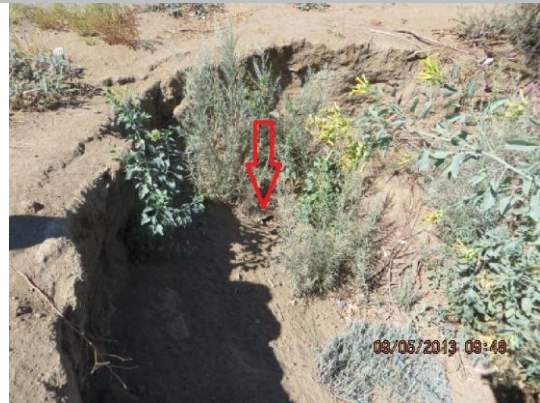
Photo 1 of 3 : UCIP\_SP\_2018\_52493\_62262.jpg

Comment Code					
Inspector Comment					
FS_ID:52493 DS_ID:20677 EP_NO: N/A Repair Type: No Action Needed Crossing Status: Found UCIP Comments: Pipe has been removed by LMA.Previous:Pipe abandoned. Erosion around pipe on WS slope. Pipe severely corroded. Pier badly damaged. FIELD_STRUCT_DESC: *REMOVED* 14-inch steel drainage pipe through the levee, 4.5 feet below the crown. Pump on pile structure in ditch on the landside (LS). Siphon breaker in corrugated metal pipe (CMP) riser on the waterside (WS) shoulder. Pipe removed by LMA. (Permit Application No. T2013179, 2014 - Surinder Sandhu, submitted to CVFPB. Permit was not needed per CVFPB review). [Additional Reference(s): DWR Levee Log, 2005. USACE San Joaquin O&M Manual 11, 1968, (HLM 0.47)]. FS Date: 9/5/2013

(Pipe removed by LMA)Pipe on WS with erosion into levee slope.

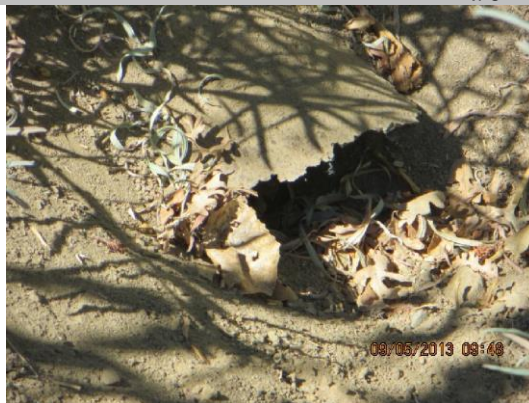
Photo 2 of 3 : UCIP\_SP\_2018\_52493\_62261.jpg

Pipe removed from WS toe.

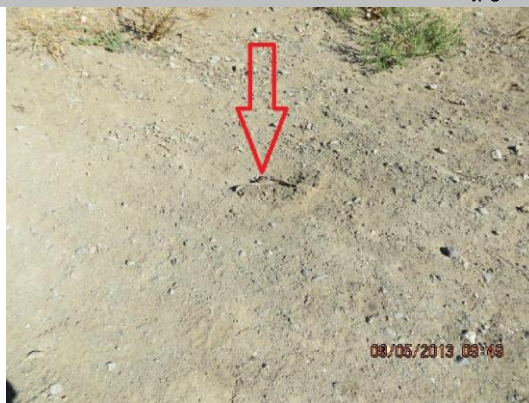
Photo 3 of 3 : UCIP\_SP\_2018\_52493\_62260.jpg

Siphon breaker in 24-inch CMP riser on WS shoulder was removed by LMA.

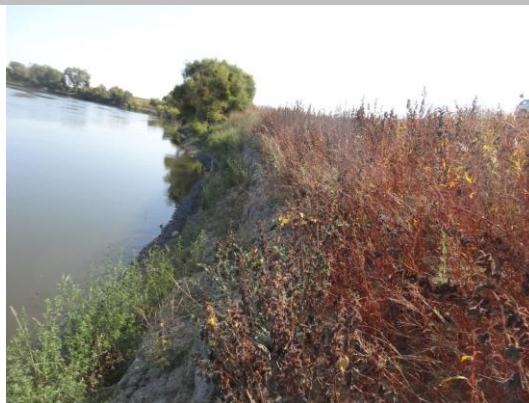
Photo 1 of 4 : SP\_2018\_RD2085\_113\_1\_20180305\_00001.jpg

Looking upstream at the erosion site. Note the dense vegetation and the trees at the upstream of the erosion.

LM Start	<b>1.15</b>	Rating **	M	Issue No.	<b>1 (cont)</b>
LM End	<b>1.26</b>	Issue Type +	Ma	Location *	WS

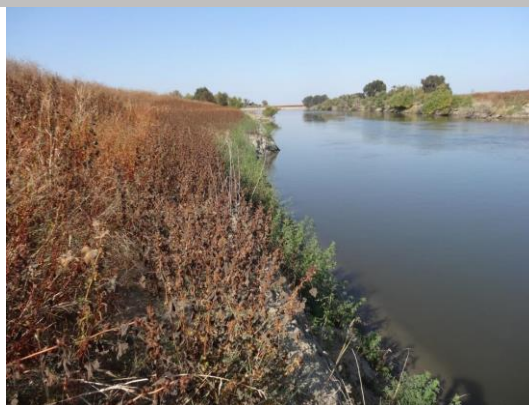
Photo 2 of 4 : SP\_2018\_RD2085\_113\_1\_20180305\_00002.jpg

Looking downstream at the erosion site.

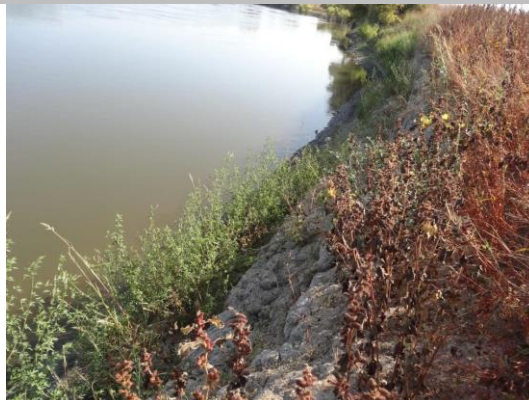
Photo 3 of 4 : SP\_2018\_RD2085\_113\_1\_20180305\_00003.jpg

Close view of the erosion.

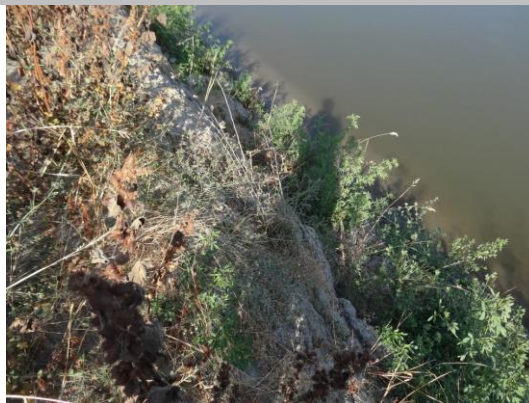
Photo 4 of 4 : SP\_2018\_RD2085\_113\_1\_20180305\_00004.jpg

Close view of the erosion.

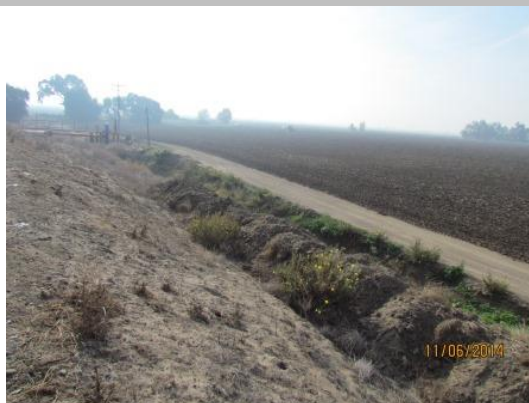
Photo 1 of 1 : SP\_2018\_RD2085\_113\_6\_20180305\_00015.jpg

LM Start	1.34	Rating **	M	Issue No.	6
LM End	1.38	Issue Type +	En	Location *	LS
Category	Earthen Levee			GPS Latitude/Longitude	
				Start	End
Item	Encroachments			37.714265 °	37.714056 °
				-121.289641 °	-121.289069 °
DWR ID	DWR_RD2085_01_s_2012_6				
Comment Code					
DT : Ditch					
Inspector Comment					
Drainage ditch at levee toe.

View of the ditch at the landside levee toe.

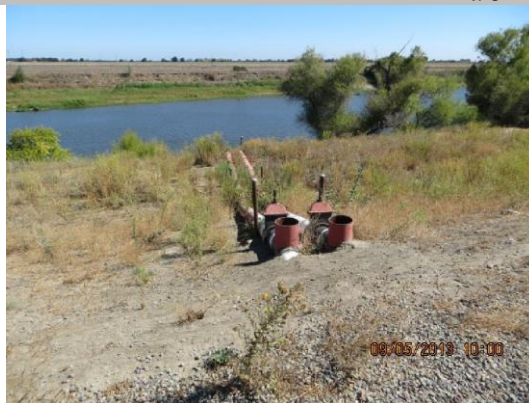
Photo 1 of 3 : UCIP\_SP\_2018\_19384\_32928.jpg

Pipe, siphon breaker, and gate valve on WS slope.

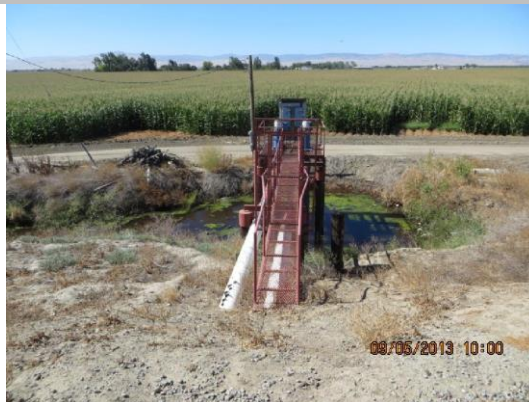
Photo 2 of 3 : UCIP\_SP\_2018\_19384\_32927.jpg

Pump on metal pier on LS toe.

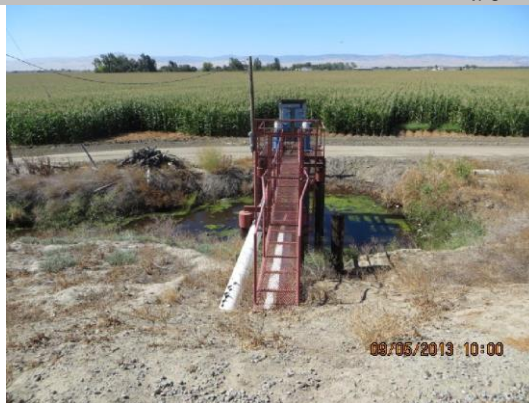
Photo 2 of 3 : UCIP\_SP\_2018\_22285\_38009.jpg

Pipe, pump, and walkway visible on LS toe.

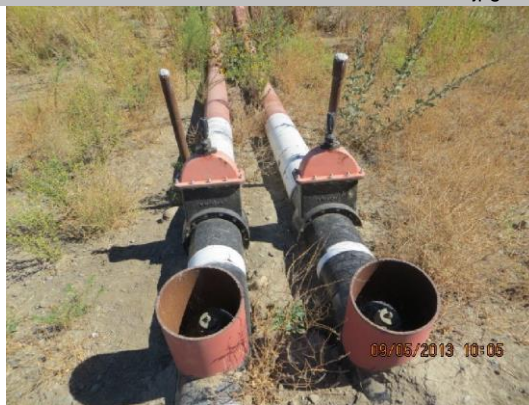
Photo 3 of 3 : UCIP\_SP\_2018\_22285\_38008.jpg

Pipe, gate valve, and siphon breaker visible on WS slope.

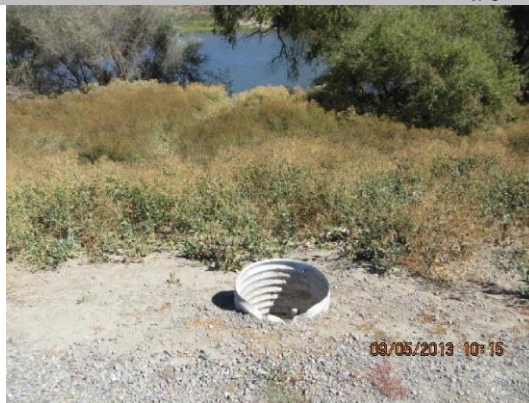
Photo 1 of 3 : UCIP\_SP\_2018\_41351\_62268.jpg

Comment Code					
Inspector Comment					
FS_ID:41351 DS_ID:20679 EP_NO: 3975 Repair Type: Non-Urgent Crossing Status: Found UCIP Comments: Pipe abandoned and should be done so properly. Large hole in ground over pipe on WS berm. Pipe rusted through on WS at river bank. No connection to pump on LS toe. FIELD_STRUCT_DESC: *ABANDONED* 10-inch steel drainage pipe through the levee, 4 feet below the crown. Steel plate over pipe end at pump station on the landside (LS) toe. Siphon breaker in a 24-inch corrugated metal pipe (CMP) riser on the waterside (WS) shoulder. (Permit No. 3975, 1962 - Glenn West Trust). [Additional Reference(s): DWR Levee Log, 2005. USACE San Joaquin O&M Manual 11, 1968, (HLM 1.35)]. FS Date: 9/5/2013

Siphon breaker in 24-inch CMP riser on WS shoulder.

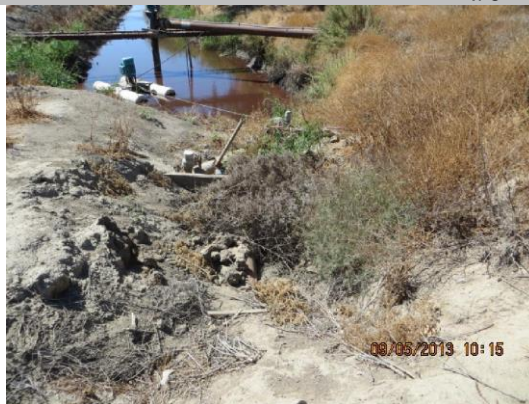
Photo 2 of 3 : UCIP\_SP\_2018\_41351\_62267.jpg

Pipe visible at bottom of ditch on LS toe.

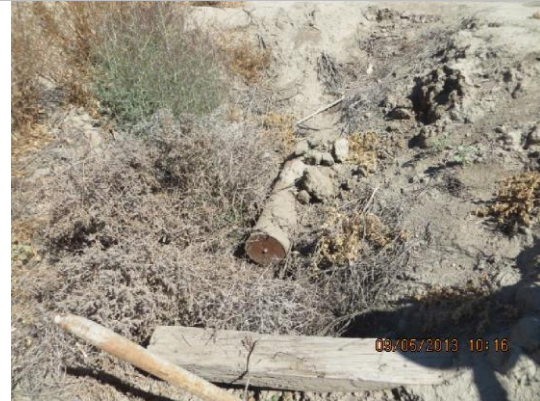
Photo 3 of 3 : UCIP\_SP\_2018\_41351\_62266.jpg

Pipe visible at bottom of ditch on LS toe.

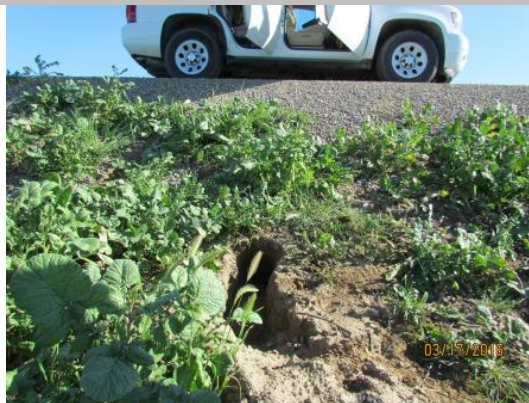
Photo 1 of 1 : SP\_2018\_RD2085\_113\_39\_20180305\_00028.jpg

View of the rodent burrows on the landside levee slope.

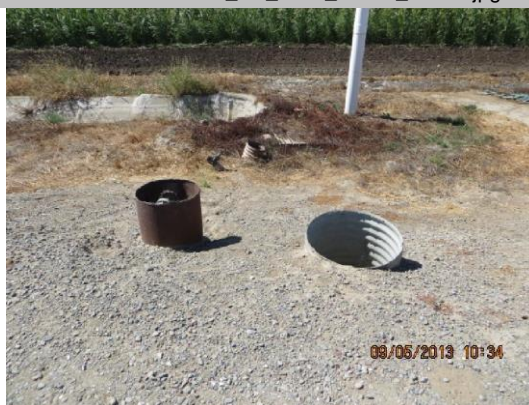
Photo 1 of 3 : UCIP\_SP\_2018\_19423\_32962.jpg

Siphon breaker in 24-inch CMP riser on LS slope. Possible gate valve at end of concrete channel on LS toe.

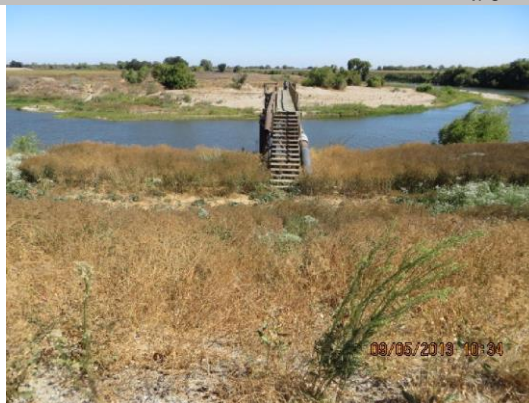
Photo 2 of 3 : UCIP\_SP\_2018\_19423\_32961.jpg

Pipe cut at wooden pier. No pump on end of pier for this pipe.

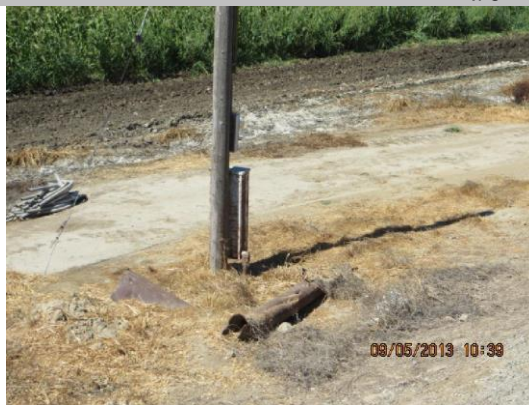
Photo 3 of 3 : UCIP\_SP\_2018\_19423\_32960.jpg

Power pole on LS toe.

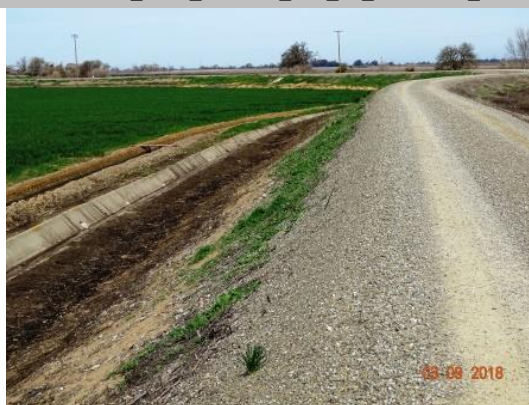
Photo 1 of 1 : SP\_2018\_RD2085\_113\_35\_20180309\_00074.jpg

View of the acceptable vegetation on the levee slope.

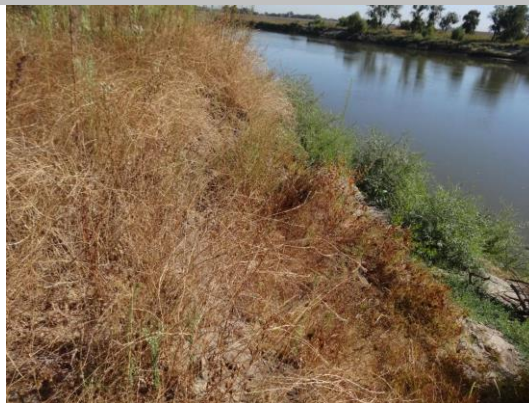
Photo 1 of 4 : SP\_2018\_RD2085\_113\_2\_20180305\_00005.jpg

10/04/2017: The erosion has progressed significantly toward the levee toe.  
 07/08/2016: No significant change observed.  
 09/10/2015: No significant change observed. Signs of animal activity are present.  
 09/10/2014: No significant change observed.  
 09/20/2013: No significant change in erosion observed. More vegetation at the site.  
 12/04/2012: The erosion has progressed remarkably toward levee, extended to the up-and downstream of the original pocket erosion. Trees and dense bush are present at the site. Animal burrow holes are visible, and possibly can cause seepage.  
 09/22/2010: No significant change observed. There is little visibility due to seasonal grass on the berm and slope.  
 08/18/2009: Site is located on berm; pocket erosion has developed; the site is covered in dense vegetation; there are several relief wells on the landside of the levee; site is Not Rated because berm width is greater than 30 feet; site should be monitored to keep track of erosion progress. [2017 Site ID:RD2085U01RM66.5]

Close view of the erosion. Note the dense vegetation at the site.

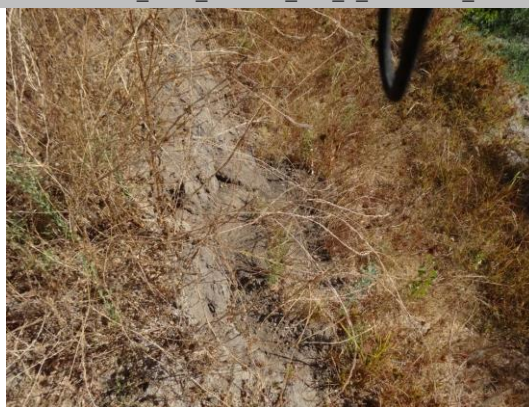
Photo 2 of 4 : SP\_2018\_RD2085\_113\_2\_20180305\_00006.jpg

Close view of the erosion.

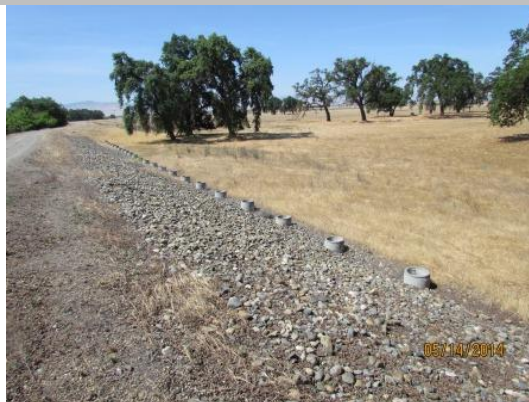
Photo 1 of 1 : SP\_2018\_RD2085\_113\_20\_20180305\_00017.jpg

View of the underseepage relief wells at the landside levee toe.

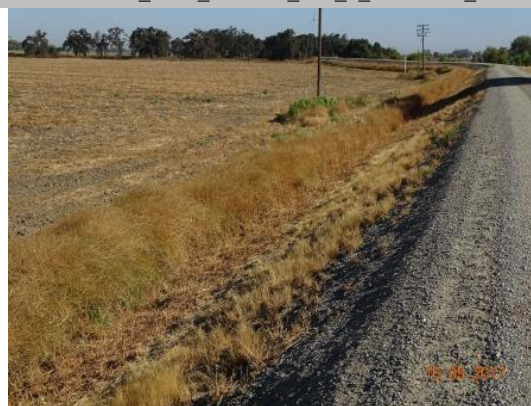
Photo 1 of 1 : SP\_2018\_RD2085\_113\_4\_20180305\_00010.jpg

View of the vegetation at the levee toe.

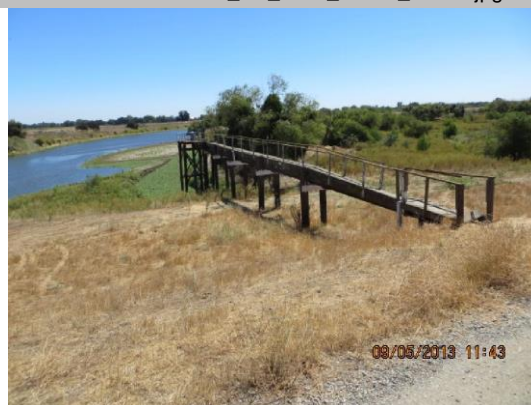
Photo 1 of 3 : UCIP\_SP\_2018\_19431\_32983.jpg

Pump on Wooden pier at WS slope.

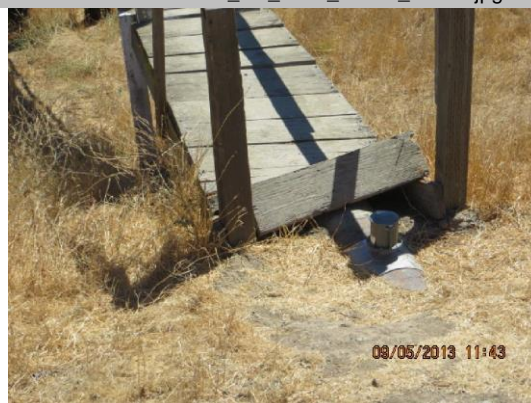
Photo 2 of 3 : UCIP\_SP\_2018\_19431\_32982.jpg

Pipe visible under walkway on WS slope.

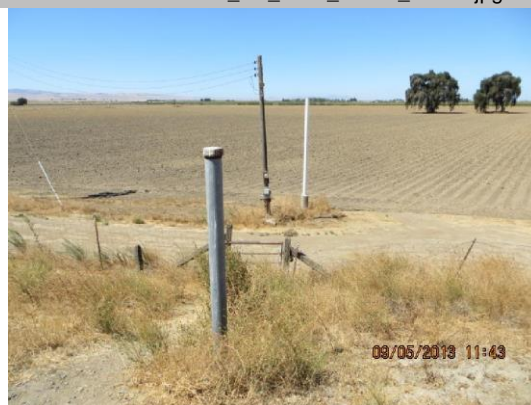
Photo 3 of 3 : UCIP\_SP\_2018\_19431\_32981.jpg

Power pole on LS toe with possible PVC riser.

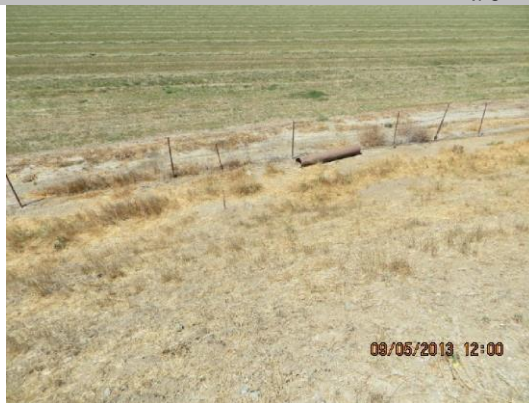
Photo 1 of 3 : UCIP\_SP\_2018\_19433\_32990.jpg

T-post marking pipe end on LS toe. 10-inch pipe debris on LS toe.

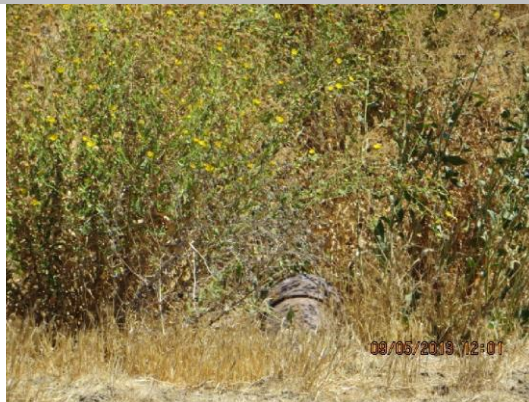
Photo 2 of 3 : UCIP\_SP\_2018\_19433\_32989.jpg

Pipe visible on WS slope.

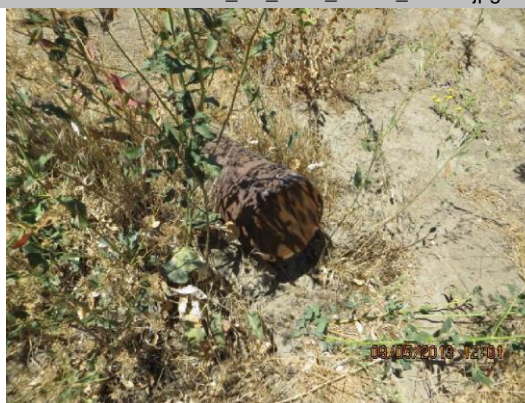
Photo 3 of 3 : UCIP\_SP\_2018\_19433\_32988.jpg

Pipe visible on WS slope. Steel plate welded over end.

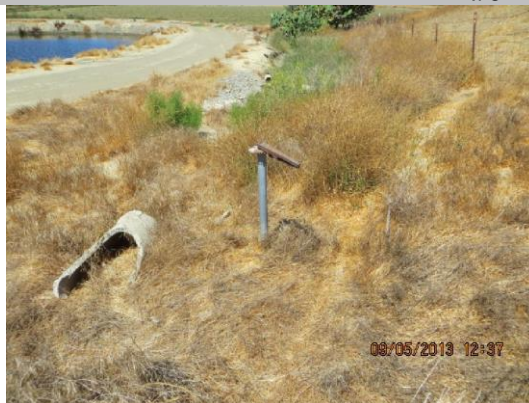
Photo 1 of 3 : UCIP\_SP\_2018\_19435\_32993.jpg

Possible Butterfly valve at LS toe.

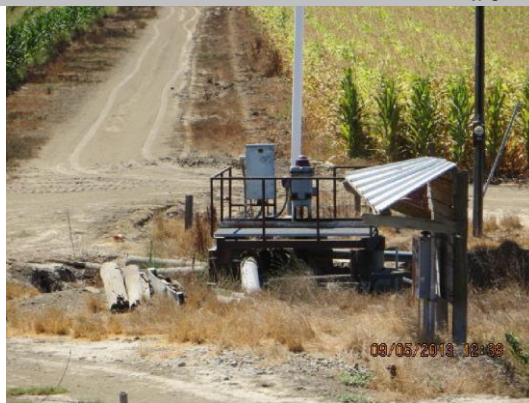
Photo 2 of 3 : UCIP\_SP\_2018\_19435\_32992.jpg

Possible connection at pump 150-feet off LS toe.

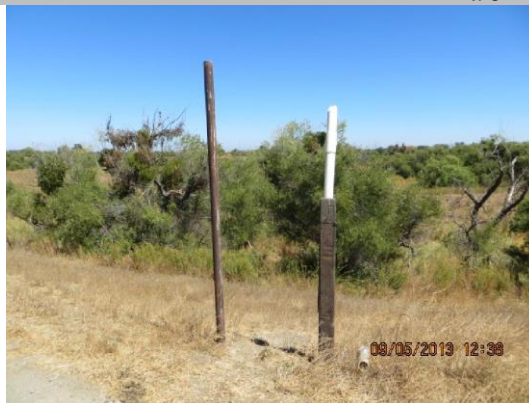
Photo 3 of 3 : UCIP\_SP\_2018\_19435\_32991.jpg

Vent on WS shoulder.

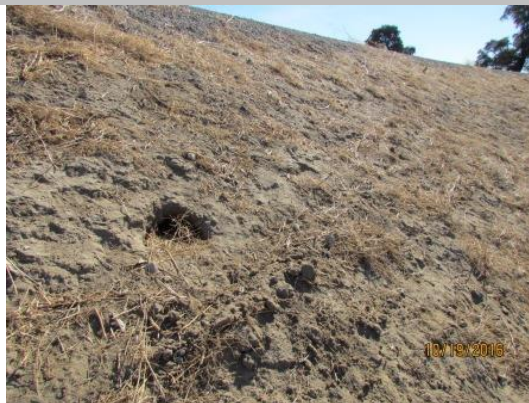
Photo 1 of 2 : SP\_2018\_RD2085\_113\_45\_20180305\_00029.jpg

View of the rodent burrows on the landside levee slope. Fall 2016

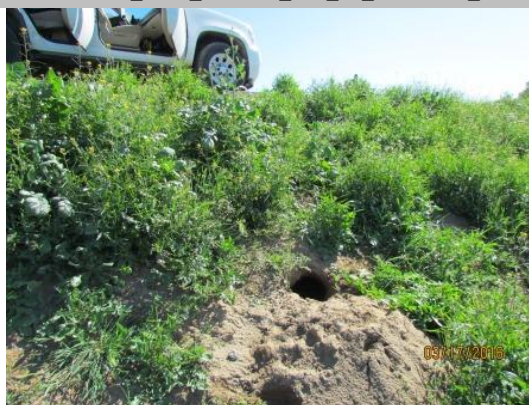
Photo 2 of 2 : SP\_2018\_RD2085\_113\_45\_20180305\_00030.jpg

View of the rodent burrows on the landside levee slope.

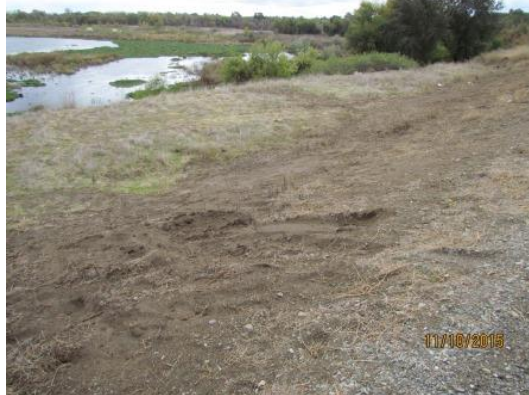
Photo 1 of 1 : SP\_2018\_RD2085\_113\_25\_20180305\_00018.jpg

LM Start	3.71	Rating **	A/W	Issue No.	25
LM End	3.71	Issue Type +	Ma	Location *	WS
Category	Earthen Levee			GPS Latitude/Longitude	
				Start	End
Item	Slope Stability			37.688216 °	37.688216 °
				-121.276603 °	-121.276603 °
DWR ID	DWR_RD2085_01_f_2015_25				
Comment Code					
S3 : Repair the levee slope damaged by vehicle traffic and prevent access where possible.					
Inspector Comment					
Control levee access to prevent damage to levee slopes by vehicle.

View of the waterside levee slope damaged by vehicle.

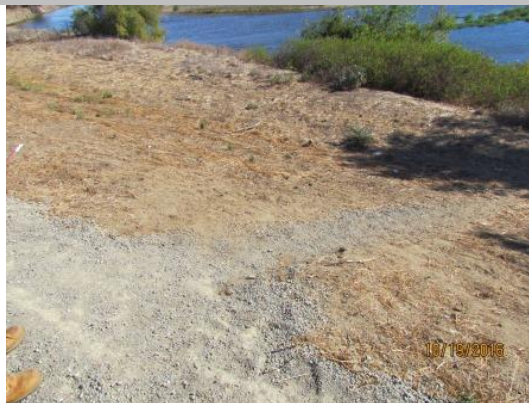
Photo 1 of 1 : SP\_2018\_RD2085\_113\_26\_20180305\_00019.jpg

View of the foot path on the levee slope.

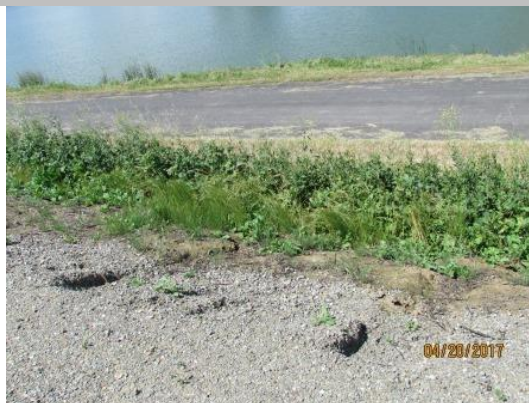
Photo 1 of 1 : SP\_2018\_RD2085\_113\_46\_20180305\_00031.jpg

View of the tire tracks on the levee slope.

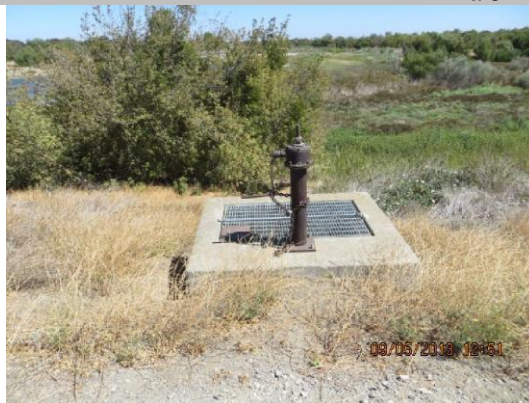
Photo 1 of 3 : UCIP\_SP\_2018\_19436\_32997.jpg

Slide gate in Concrete riser on WS shoulder.

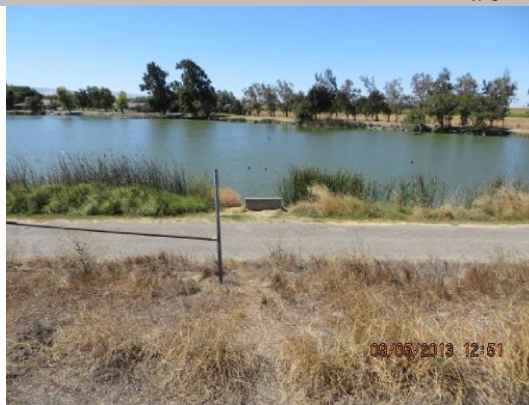
Photo 2 of 3 : UCIP\_SP\_2018\_19436\_32996.jpg

Concrete headwall off LS toe.

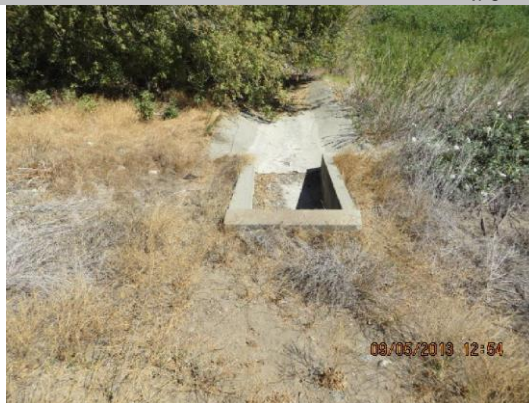
Photo 3 of 3 : UCIP\_SP\_2018\_19436\_32995.jpg

Concrete U-shaped headwall on WS slope.

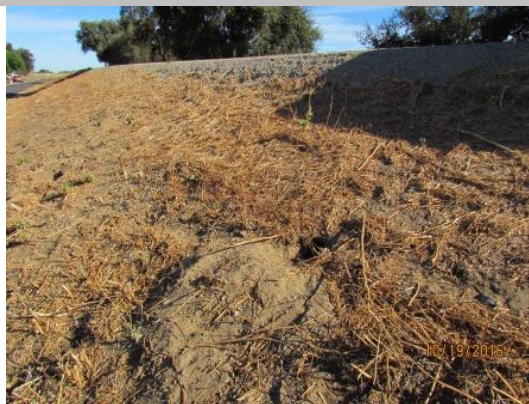
Photo 1 of 1 : SP\_2018\_RD2085\_113\_36\_20180305\_00027.jpg

View of the rodent holes on the levee slope.

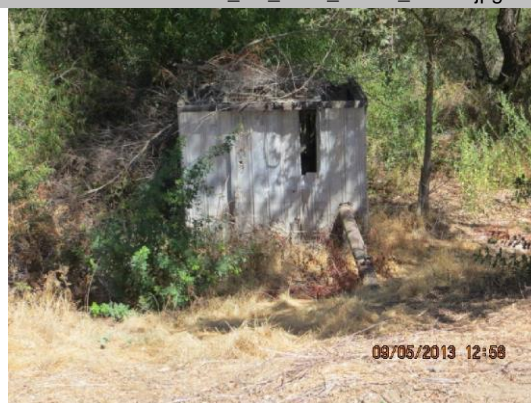
Photo 1 of 3 : UCIP\_SP\_2018\_19443\_33002.jpg

Pumphouse and pipe visible on WS toe.

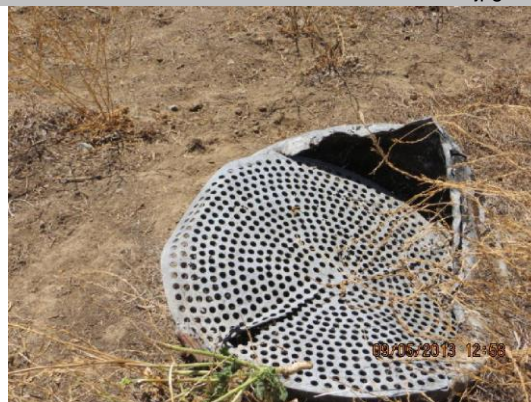
Photo 2 of 3 : UCIP\_SP\_2018\_19443\_33001.jpg

Siphon breaker on vent in 24-inch CMP riser on LS shoulder.

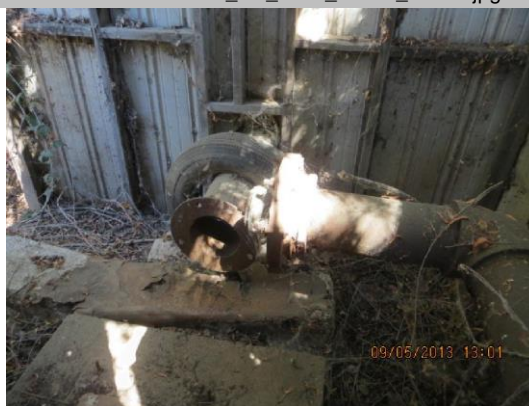
Photo 3 of 3 : UCIP\_SP\_2018\_19443\_33000.jpg

Pump missing from pipe in pumphouse on WS toe.

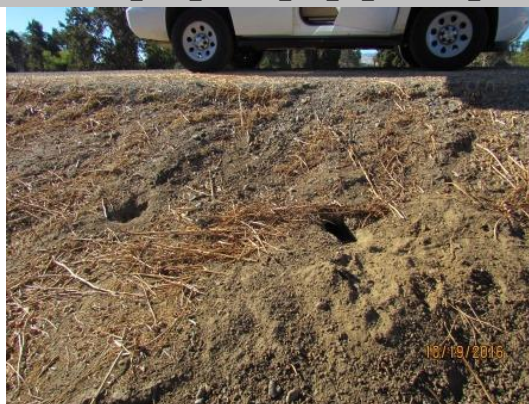
Photo 1 of 1 : SP\_2018\_RD2085\_113\_34\_20180305\_00026.jpg

View of the rodent holes on the levee slope.

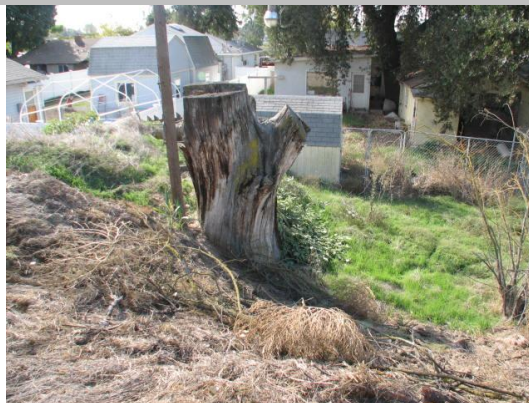
Photo 1 of 1 : SP\_2018\_RD2085\_113\_32\_20180305\_00023.jpg

11/03/2011 Large stump on landside slope.

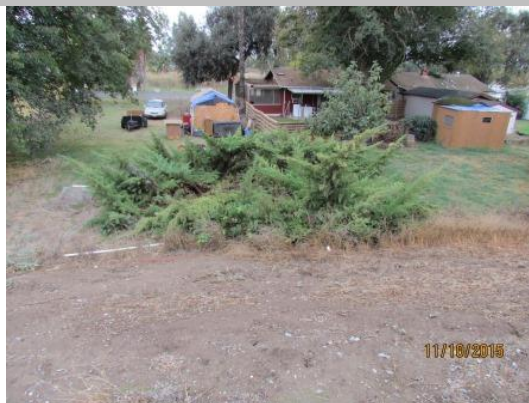
Photo 1 of 1 : SP\_2018\_RD2085\_113\_28\_20180305\_00021.jpg

View of the unmaintained vegetation at the landside levee toe.

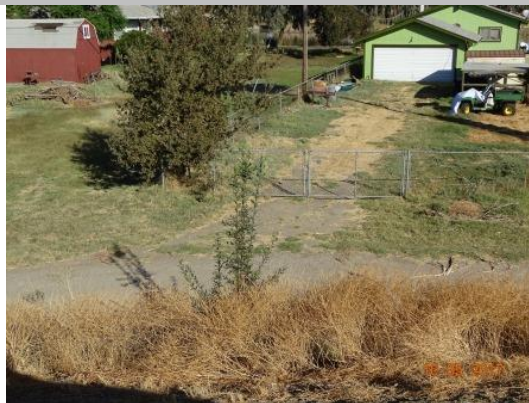
Photo 1 of 1 : SP\_2018\_RD2085\_113\_3\_20180305\_00009.jpg

View of the volunteer tree at the levee toe.

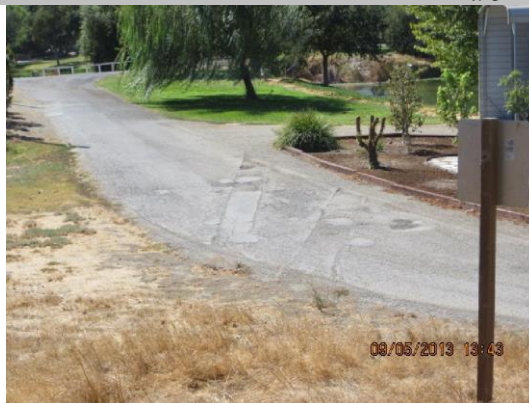
Photo 1 of 3 : UCIP\_SP\_2018\_23060\_39184.jpg

Cuts in pavement off LS toe good indicator of pipe location.

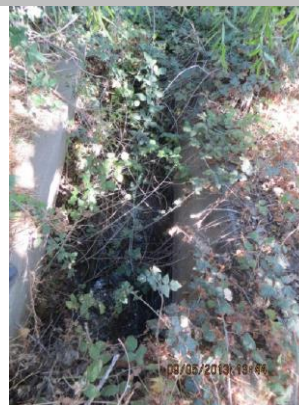
Photo 2 of 3 : UCIP\_SP\_2018\_23060\_39183.jpg

Concrete U-shaped headwall visible on WS toe.

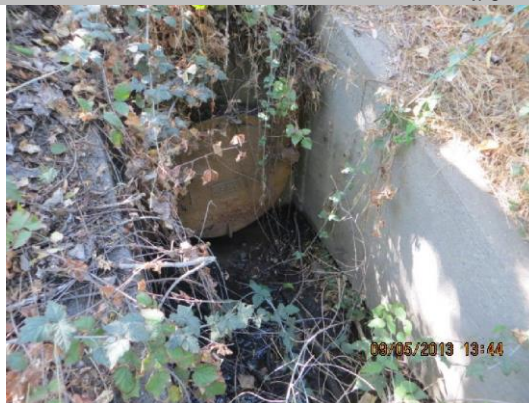
Photo 3 of 3 : UCIP\_SP\_2018\_23060\_39182.jpg

Concrete U-shaped headwall and flapgate visible on WS toe.

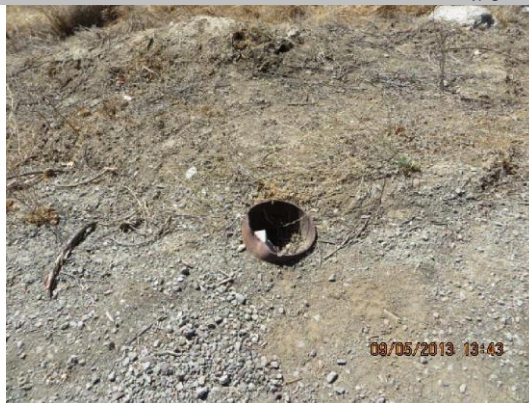
Photo 1 of 3 : UCIP\_SP\_2018\_22290\_38020.jpg

Siphon breaker in 10-inch steel riser on LS shoulder.

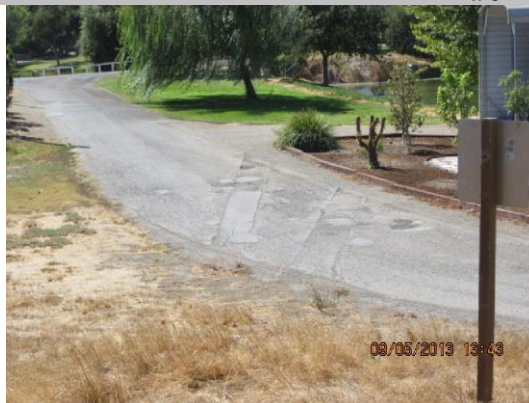
Photo 2 of 3 : UCIP\_SP\_2018\_22290\_38019.jpg

Cuts in pavement may indicate alignment of pipe at LS toe.

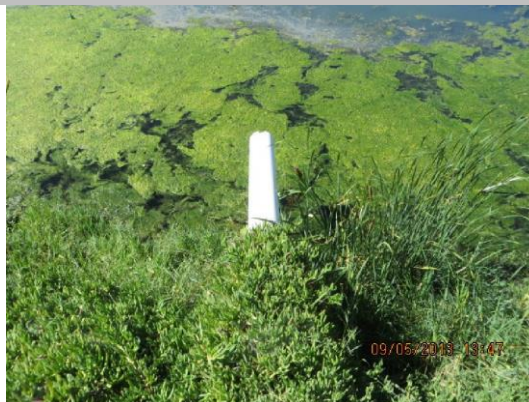
Photo 3 of 3 : UCIP\_SP\_2018\_22290\_38018.jpg

Pipe visible at pond outlet off LS toe.

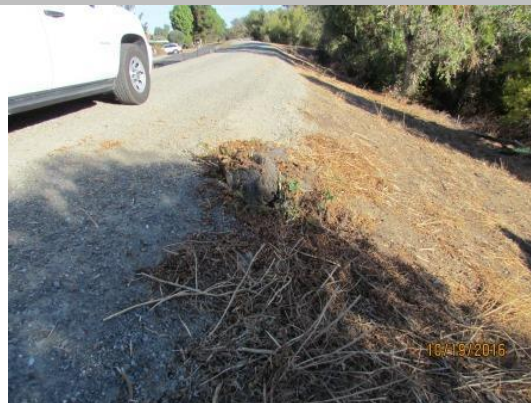
Photo 1 of 1 : SP\_2018\_RD2085\_113\_29\_20180305\_00022.jpg

View of the tree stump.

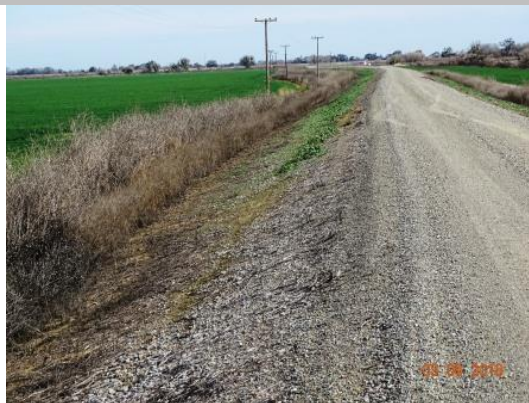
Photo 1 of 1 : SP\_2018\_RD2085\_114\_1\_20180309\_00001.jpg

View of the acceptable vegetation on the levee slope.

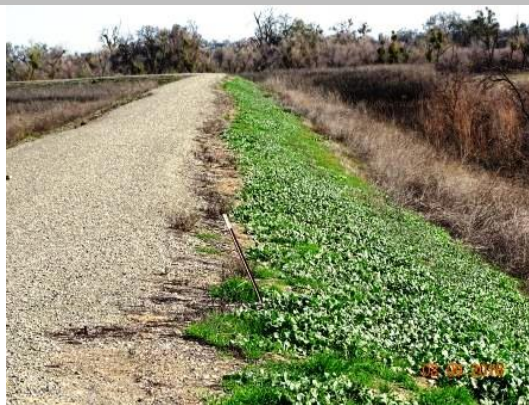
Photo 1 of 1 : SP\_2018\_RD2085\_115\_2\_20180309\_00004.jpg

View of the acceptable vegetation on the levee slope.

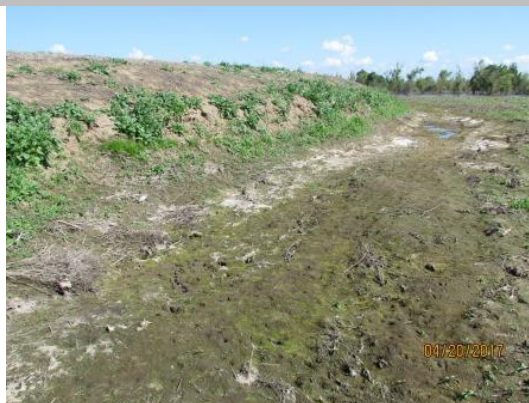
Photo 1 of 3 : SP\_2018\_RD2085\_115\_1\_20180305\_00001.jpg

View of the erosion at the waterside levee toe. Spring 2017.

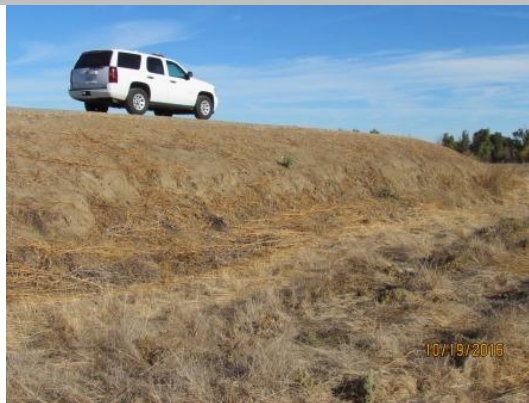
Photo 2 of 3 : SP\_2018\_RD2085\_115\_1\_20180305\_00002.jpg

View of the erosion at the waterside levee toe. Fall 2016.

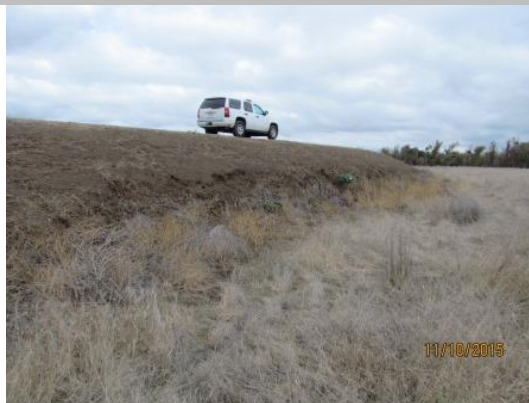
Photo 3 of 3 : SP\_2018\_RD2085\_115\_1\_20180305\_00003.jpg

View of the erosion at the waterside levee toe.
